# PICKEREL LAKE LEVEL CONTROL STRUCTURE PART 307 INSPECTION

Dam Identification No.: 2553  
Hazard Potential: Low  
Section 4, T. 15 N. – R.09 W.  
Colfax and Grant Townships, Mecosta County, Michigan

Date of Inspection: April 4, 2017  
Date of Report: April 2017

Project I.D. Number 124563SG2017

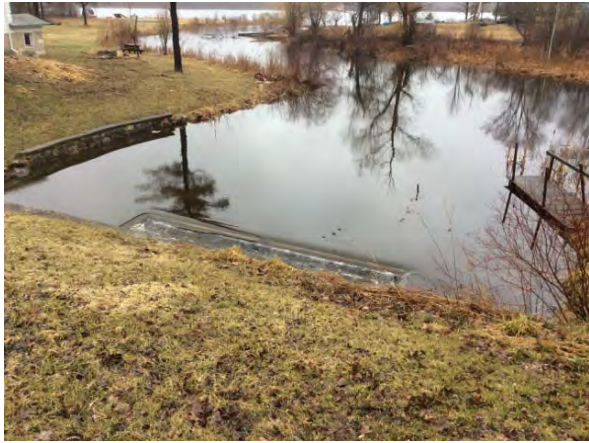
Upstream embankment/road slope towards control structure

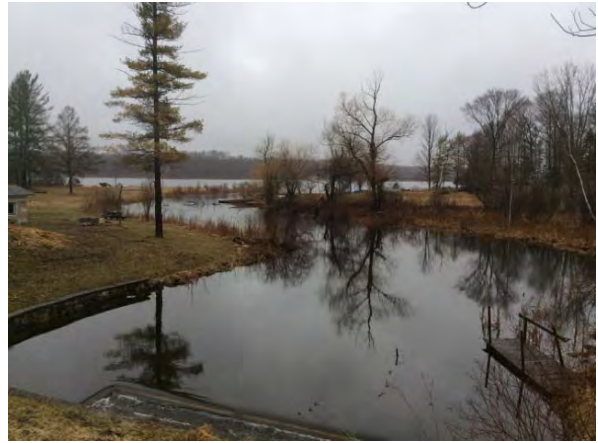
Upstream impoundment/channel

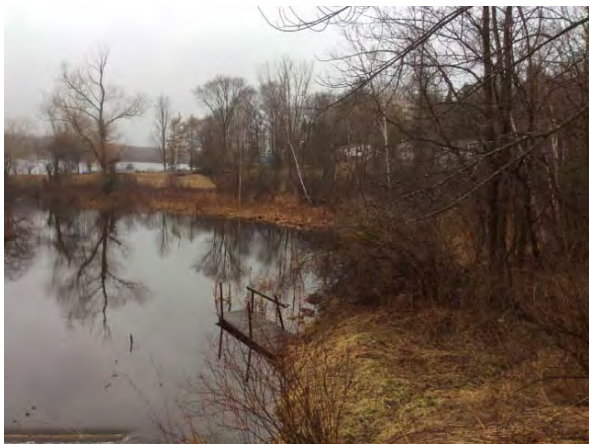
Left side upstream approach channel

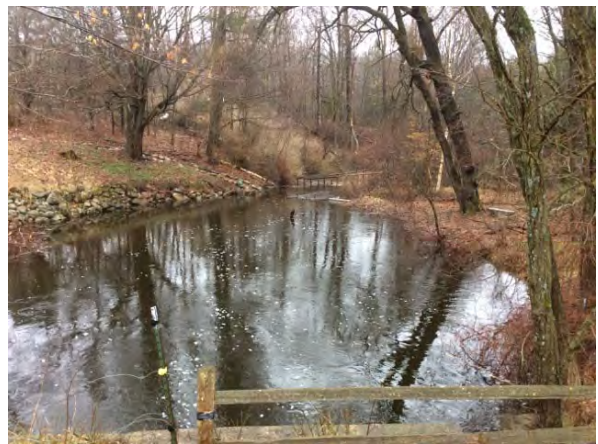
Downstream channel

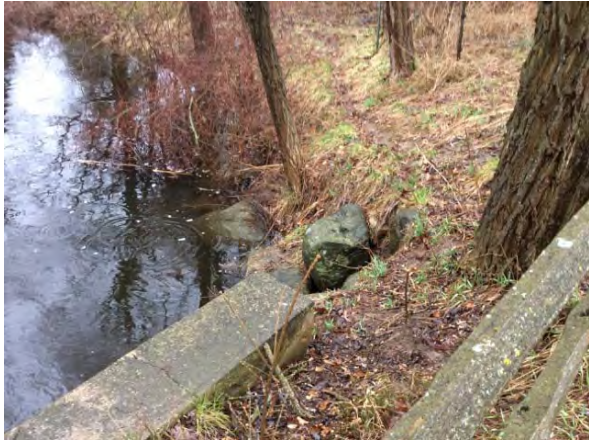
Riprap protection right toe of headwall  
Note crack across headwall in foreground

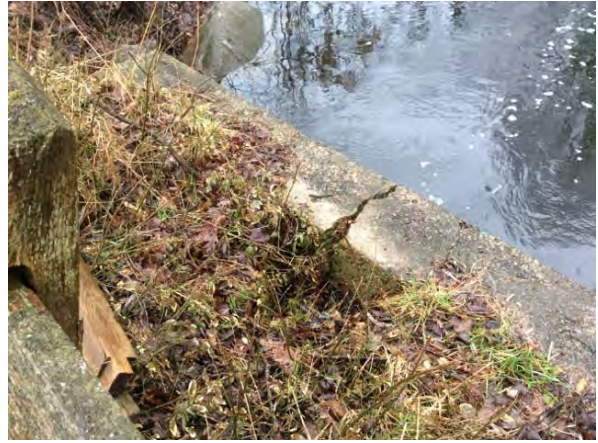
Crack in headwall and settlement behind headwall

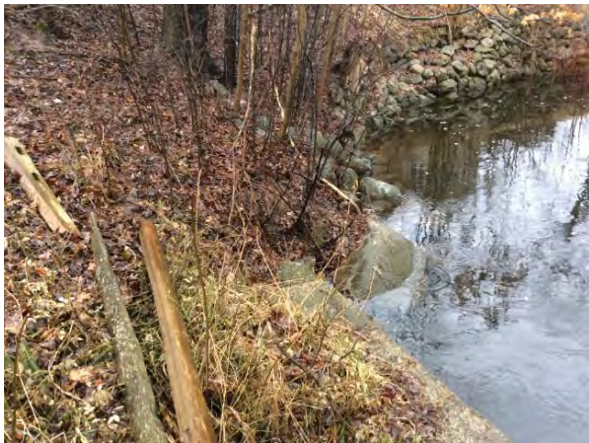
Left side downstream channel

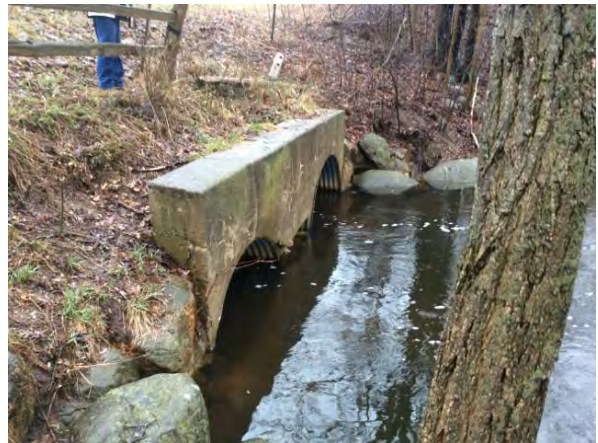
Downstream face of headwall for outlet culverts

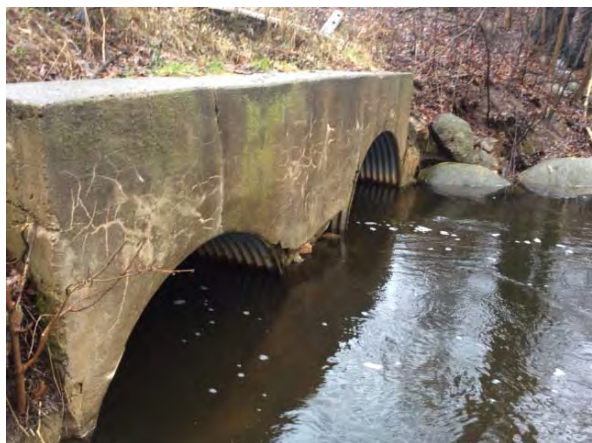
CONCRETE STRUCTURE: Check for erosion; location of cracking or spalling. If old or new; settlement; need for crack repairs. <b>UPSTREAM HEADWALL: Severe spalling, up to 13" deep in some locations, throughout.</b>  <b>DOWNSTREAM HEADWALL: Loss of concrete at right toe and in the center between culverts.</b>	
WALKWAY & RAILING: Check if in place or removed, condition, and if adequate protection provided.  N/A	TRASHRACK OR LOG BOOM: Check if operable.  N/A
EMERGENCY SPILLWAY: Size, type, and condition.  N/A

Loss of concrete on right side and middle of downstream headwall

**1 – Recommend to County Road Commission that upstream and downstream headwalls be rehabilitated or replaced.**  
**2 – Establish on site benchmark (hub or staff gage) to facilitate measurement of legal lake level.**

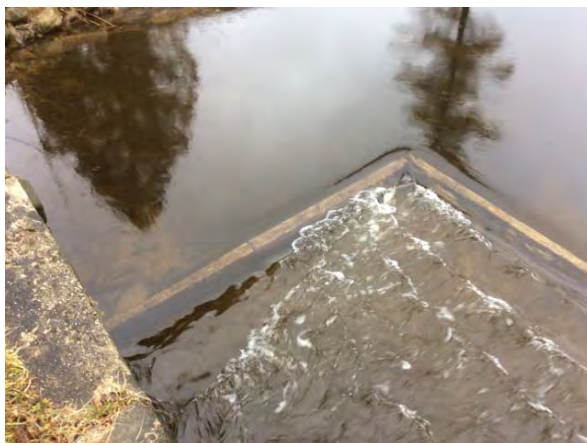
Right side of stop log bays

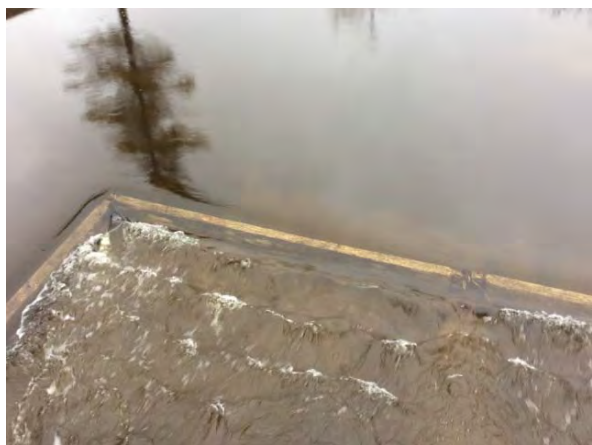
Right middle of stop log bays

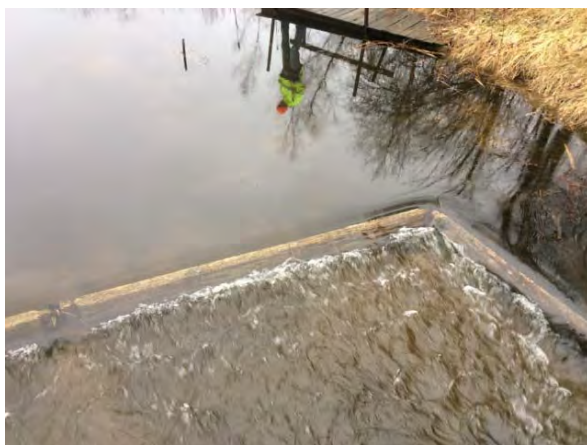
Left middle of stop log bays

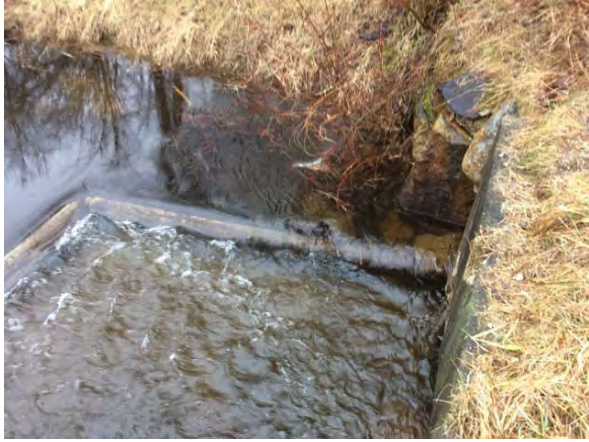
Left side of stop log bays

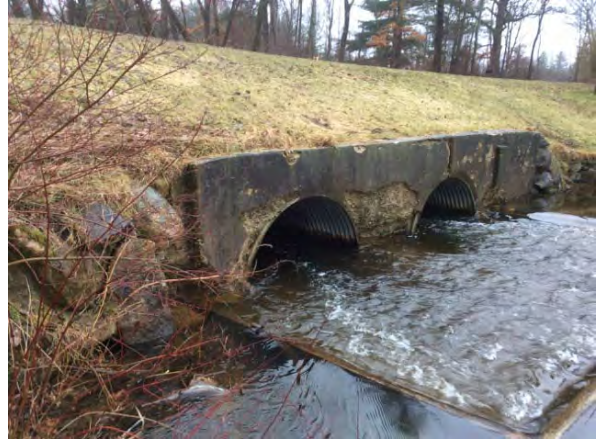
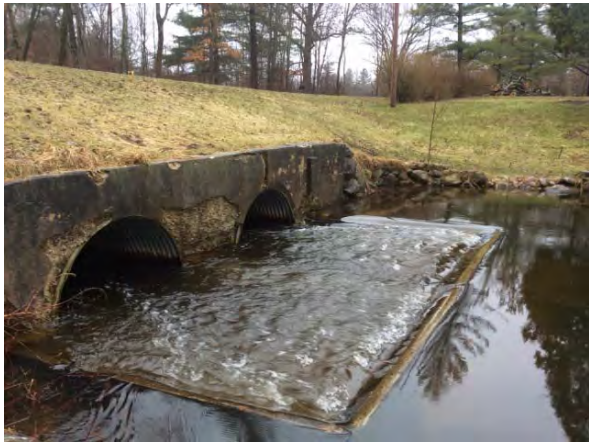
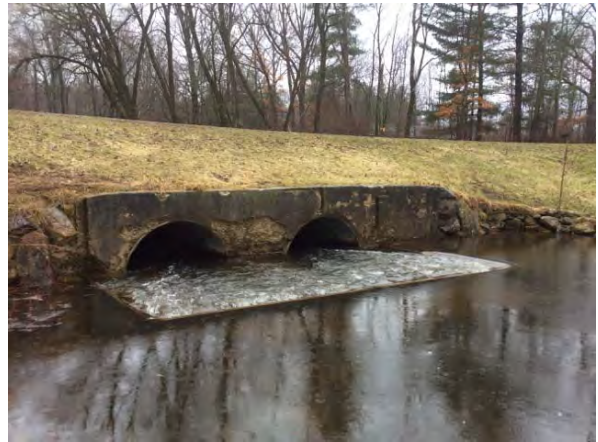
Spalling and loss of concrete on upstream headwall

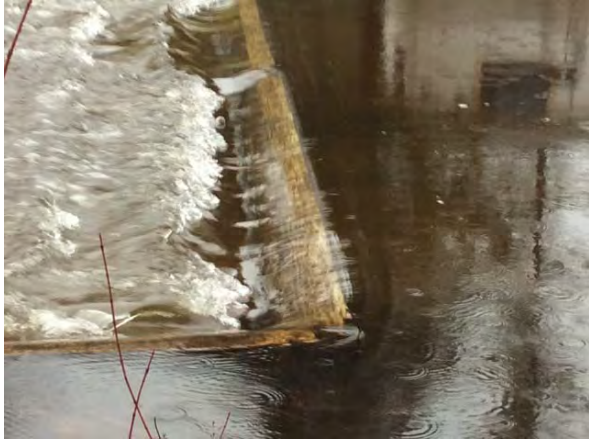
<p>STOPLOG VALVES AND GATES (open and close to check condition): Check location of top stoplog in relation to top of riser pipe intake box or fixed crest, for leakage, and condition of stoplogs, valves and gates. <b>STOP LOGS ARE IN GOOD CONDITION – NO DETERIORATION OBSERVED.</b></p>
<p>OUTLET PIPE: Check for damage from ice, logs, vandalism; inside discharge pipe for settlement and/or joint separation; condition of pipe coating. <b>TWO GALVANIZED CMP CULVERTS (NO COATING OBSERVED). PORTION BELOW WATERLINE HAS SURFACE RUSTING – NO SECTION LOSS OBSERVED.</b></p>

Zoom in photo of wooden stop logs
